FINAL REPORT

DESIGN VERIFICATION TESTING (DVT) FOR THE NEW CONTROL CABINET UNIT

Prepared for
Federal Aviation Administration
Under FAA Contract No. 04-G0012

Prepared by
Engineering and Technology Group
Hemispheric Center for Environmental Technology
Florida International University

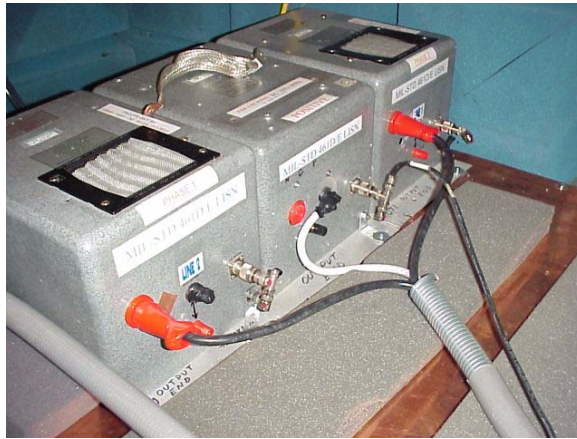
Figure 2 CE102 Conducted Emission Compatibility Test Setup

This method was used to confirm that electromagnetic emissions from the Control Cabinet Unit do not exceed the specified requirements for power input leads and returns. Test was conducted in the range of 10 KHz - 10MHz and the test procedure at medium intensity settings. Figure 2 depicts the setup used during this test.

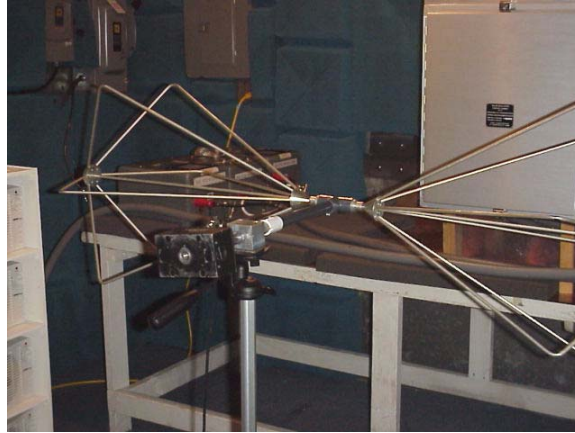
Figure 3 CS114 Conducted Susceptibility Compatibility Test Setup

This method is used to confirm the ability of the Control Cabinet Unit to withstand RF signals coupled onto equipment under testing associated cabling. The test was conducted between the ranges of 10KHz - 400MHz and the test procedure at low intensity settings. Figure 3 depicts the setup used during this test.

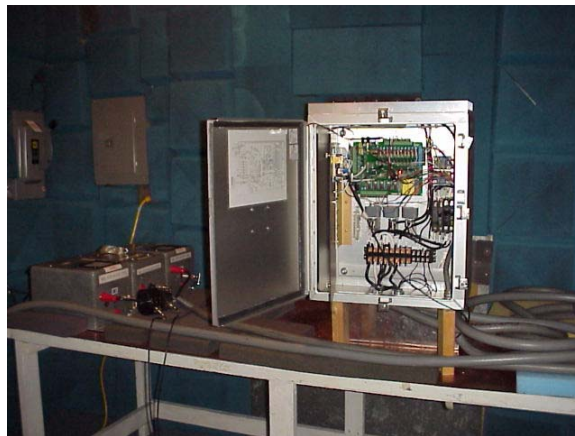
Figure 4 RE102 Radiated Emission Compatibility Test Setup

This test is used to confirm that electric field emissions from the Control Cabinet and its associated cabling do not exceed specified requirements. The test was conducted in the range of 10KHz - 18GHz and the test procedure at medium intensity settings. Figure 4 below depicts the setup used during this test.

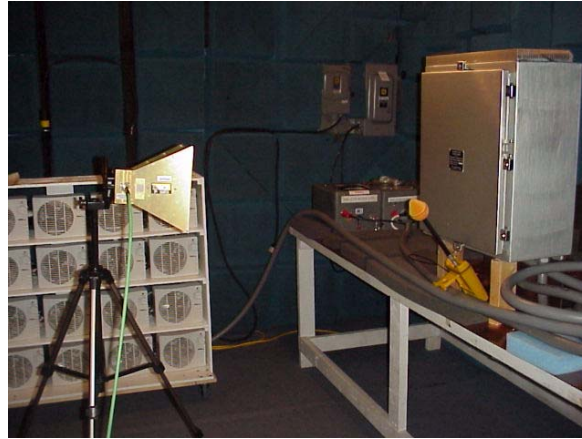
Figure 5 RS103 Radiated Susceptibility Compatibility Test Setup

This method is used to confirm the ability of the equipment under test and associated cabling to withstand electric fields. The test was conducted in the range of 10KHz - 40GHz and the test procedure at low intensity settings. Figure 5 depicts the setup used during this test.

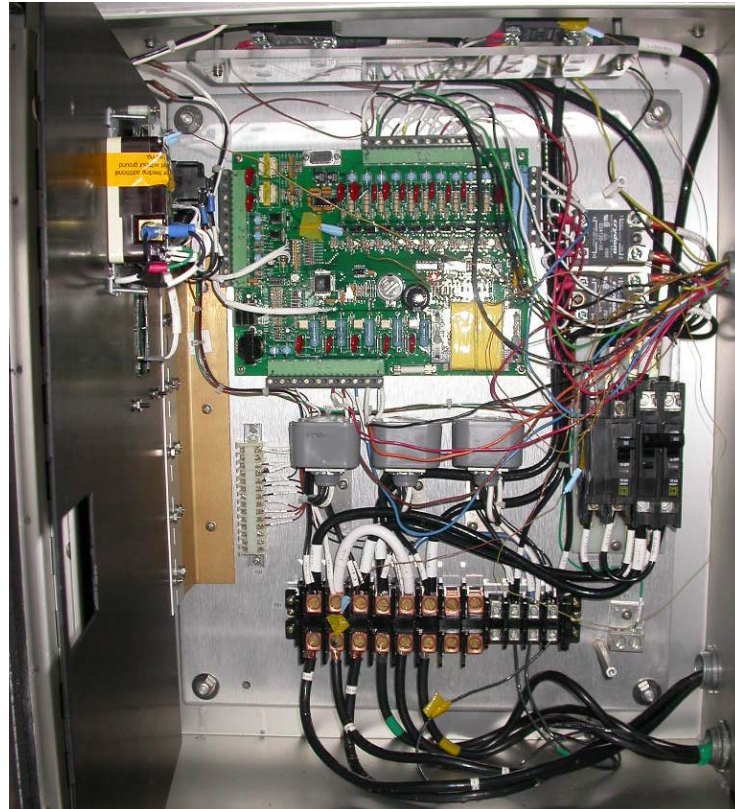
Figure 7 Cabinet unit after the High Temperature Exposure

The CCU system operated at high intensity during the high temperature exposure test, although temperatures above +70 °C were found in some of the components. After the exposure, visual examination did not reveal any indication of damage. Figure 7 presents the interior components of the control cabinet after exposure.

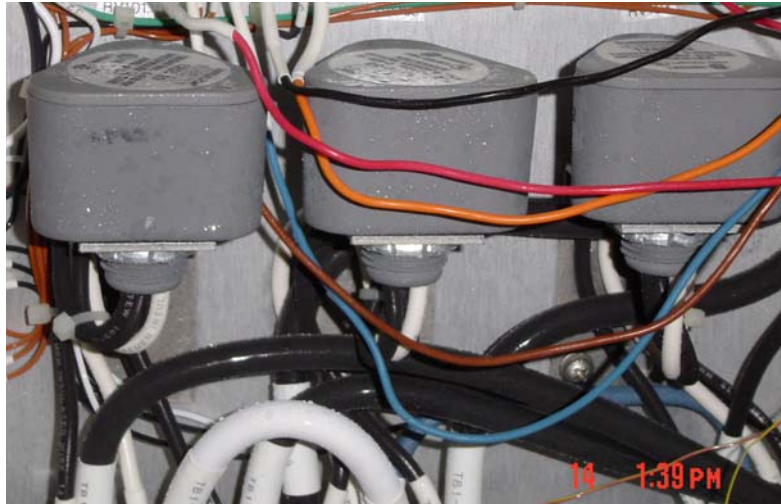
Figure 8 Picture displaying Droplets formed during the Low Temperature Exposure

The CCU system operated at low intensity during the entire low temperature exposure, although one sequential flasher LED light did not work in the last cycle of the 3 cycle test. An oscilloscope was also used to measure the pulse under each one of the working intensities of the CCU, since the oscilloscope measured a pulse it was concluded that the CCU was working as intended. After the exposure, visual examination did not reveal any indication of damage, some moisture and frost was found due to the low temperature. Figure 8 shows some of the moisture and frost detected after the test.

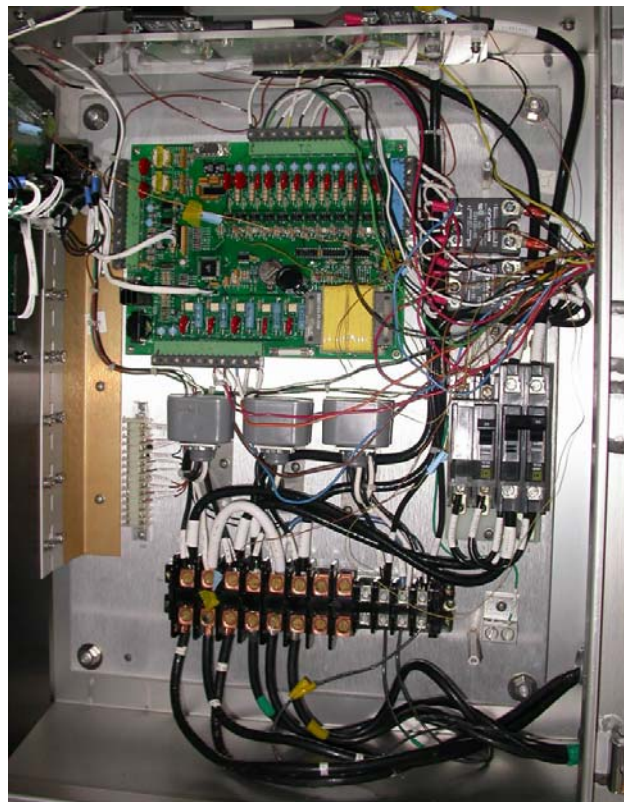
Figure 9 Control Cabinet Unit after Humidity Exposure

The CCU system operated during the entire humidity exposure, although one sequential flasher LED light did not work during all the 5 cycles of the test. Pulse was measured using an oscilloscope and it was determined that the flashing LED light was out. After the exposure, visual examination did not reveal any indication of damage (see Fig. 9).

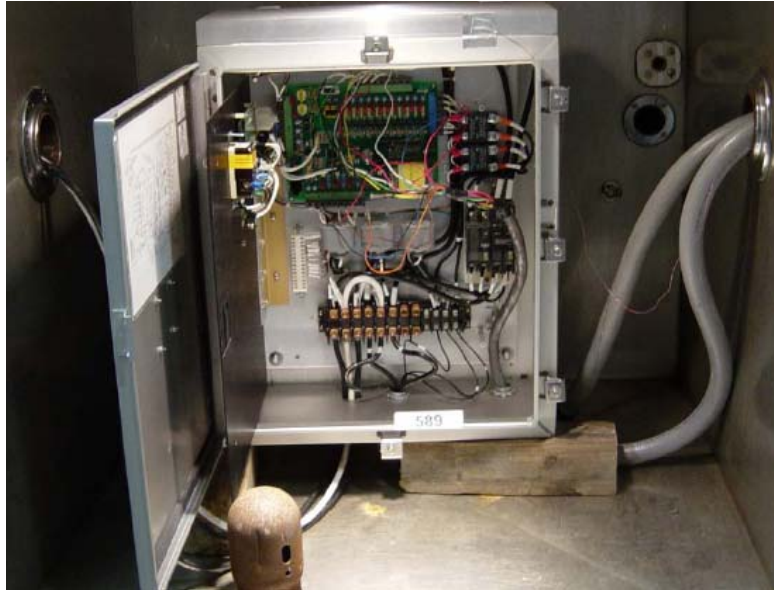
Figure 10 Cabinet Unit after the Altitude test

The CCU system operated during the altitude (Low pressure) test. After the exposure, visual examination did not reveal any indication of damage. Figure 10 shows the system after the test.

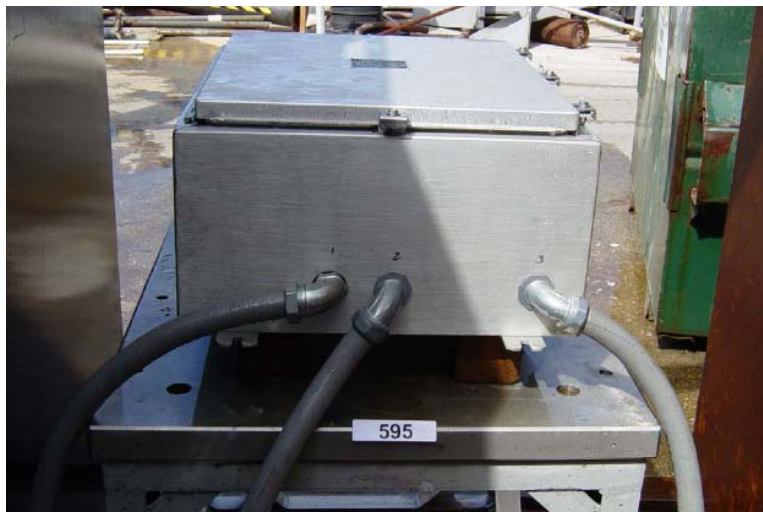
Figure 11 Picture displaying the Cabinet unit after Rain Exposure

The CCU system operated during the entire rain exposure, although the current measured in L2 when operated in “remote mode” and “local mode” was in the range specified by DME. After the exposure, a visual examination did not reveal any indication of damage. Figure 11 shows the system during the rain exposure.

Only a small amount of water was detected during the rain exposure to the bottom surface of the cabinet unit. It is believed that water penetrated the cabinet through the compression fitting and seals. This was due to the excessive number of times that the fitting and seals were removed during the setup and breakdown of the electrical connections to the cabinet unit. This is an unlikely situation since the cabinet units are installed in an upright position and cables come through the bottom of the cabinet, it is extremely unlikely that this surface will be exposed to rain.

From the environmental testing point of view, the cabinet performed as expected, only a small amount of water was detected during the rain exposure to the bottom surface of the cabinet unit. It is believe that water penetrated the cabinet through the compression fitting and seals. This was due to the excessive number of times that the fitting and seals were removed during the setup and breakdown for each environmental test. This is an unlikely situation since the cabinet units are installed in an upright position and cables come through the bottom of the cabinet, it is extremely unlikely that this surface will be exposed to rain. It is recommended that for future DVT test, a 4 ft long “pig tail” connection is provided so that connection are made outside the cabinet without having to connect and disconnect the cables.

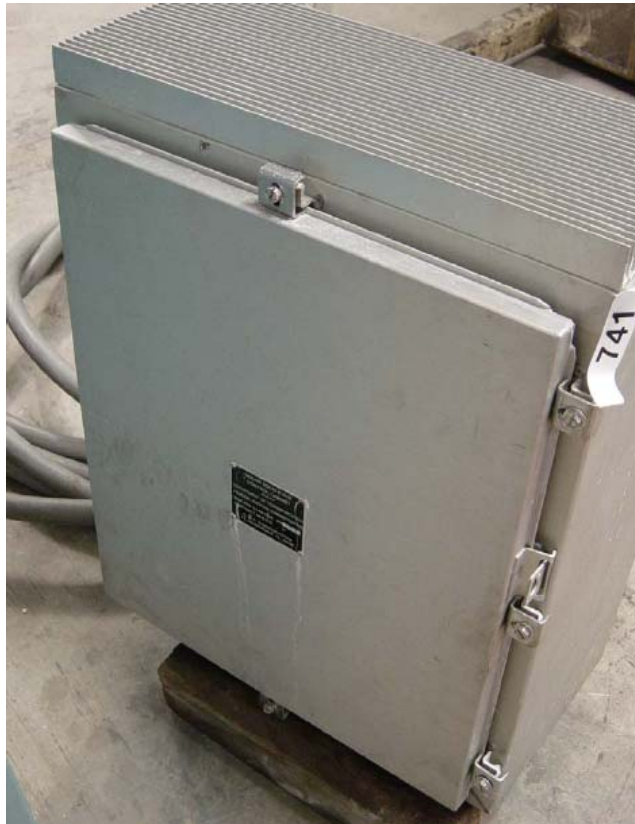
Figure 12 Control Cabinet Unit after Salt Exposure

The CCU system operated during the exposure, although some of the sequential flasher LED's did not work. After the exposure, rust was noted on the top of the test unit next to heat sink and some salt trails on all sides and corrosion on conduit was observed during the visual inspection. Figure 12 shows the cabinet after salt test exposure.

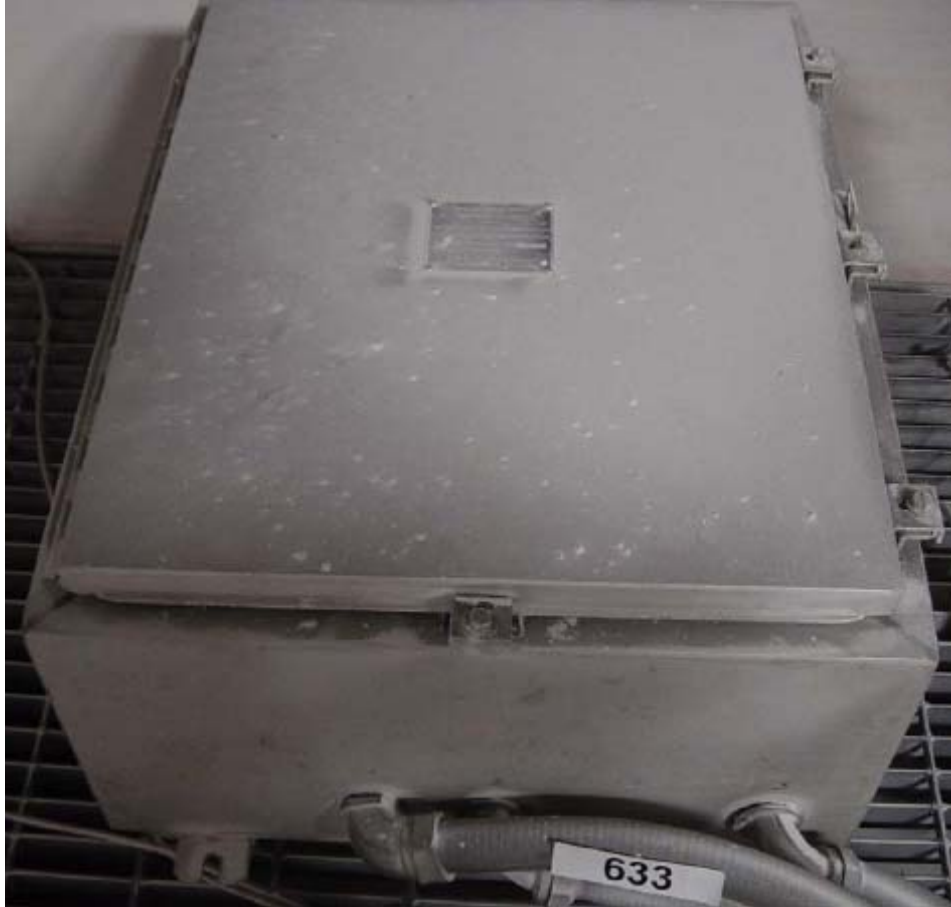
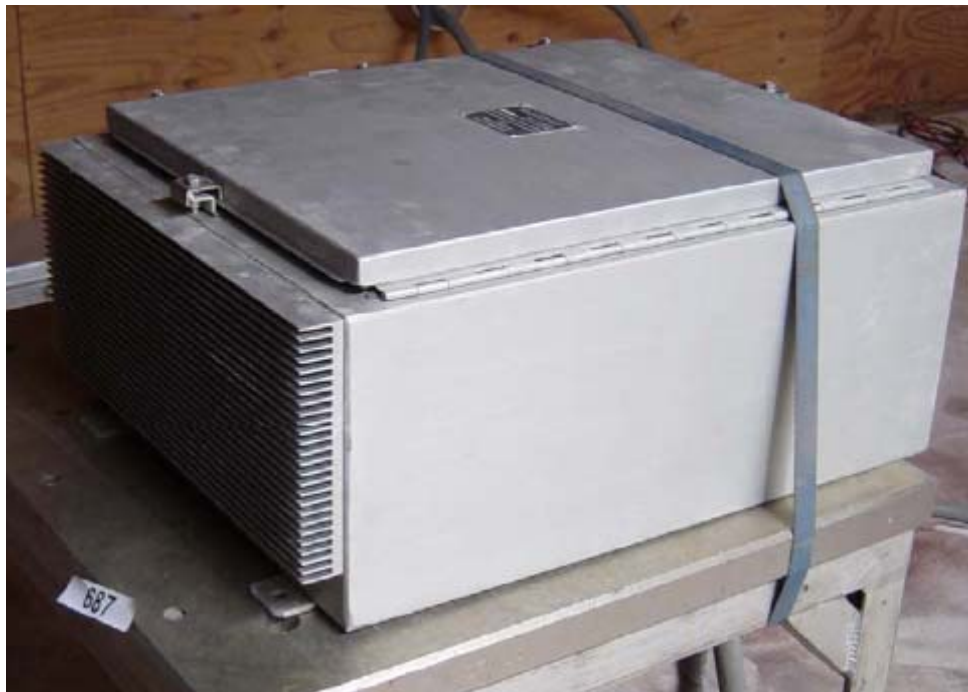
Figure 13 Pictures Displaying Cabinet unit after Sand and Dust Exposure

The CCU system operated during the exposure to sand and dust. After the exposure, visual examination did not reveal any indication of damage. Figure 13 show two pictures of the cabinet after Sand and Dust exposure test.
